BTRF CONTRACTOR RECORDABLE INJURY: FOOT INJURY FROM OUTRIGGER

On February 28, 2012, a contract rigger at the CLEU-2 T/A was injured when a carry deck crane outrigger was lowered onto his right foot. The contractor was examined at a local hospital where x-rays revealed two fractures to the foot. The incident is under investigation.

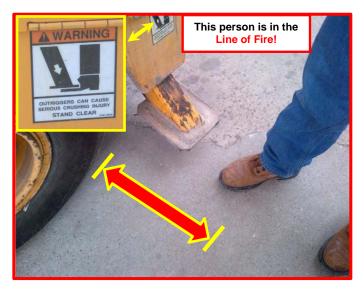
- ➤ The rigger was standing at the right front of the carry deck crane, spotting for a contract crane operator as the carry deck crane was backed out of the unit and onto Crosby Street.
- ➤ The rigger noticed the right rear outrigger was not fully retracted and alerted the operator.
- The operator stopped and attempted to raise the outrigger, but in the process operated the wrong lever resulting in the front outrigger being deployed down onto the rigger's right foot.
- ➤ The outrigger alarms sounded as the outriggers were lowered.
- The injured worker was wearing safety toed boots, which minimized the severity of the injury.

Outriggers come out at an angle not straight down

- > Stay clear of the outrigger Danger Zone at all times. (See Warning Label in picture)
- ➤ Carry deck cranes have alarms that signal when an outrigger is being deployed. Heed the alarm when it sounds.
- ➤ The crane operator and injured worker failed to recognize the Line of Fire hazard.
- Good, clear communications between workers is critical and key to ensuring each task is performed safely and to avoid incidents.
- Always ensure everyone is totally clear of mobile equipment before touching any controls.
- Use the SCAN process to identify hazards around mobile equipment.
