SWIVEL SNAPHOOK INSPECTION NOTIFICATION

Inspection notice for GFP products featuring a possible unsafe condition due to a supplier defect in a specific style of swivel snaphook supplied to Guardian between 8/26/2011 and 6/25/2012

Date: 6/26/2012

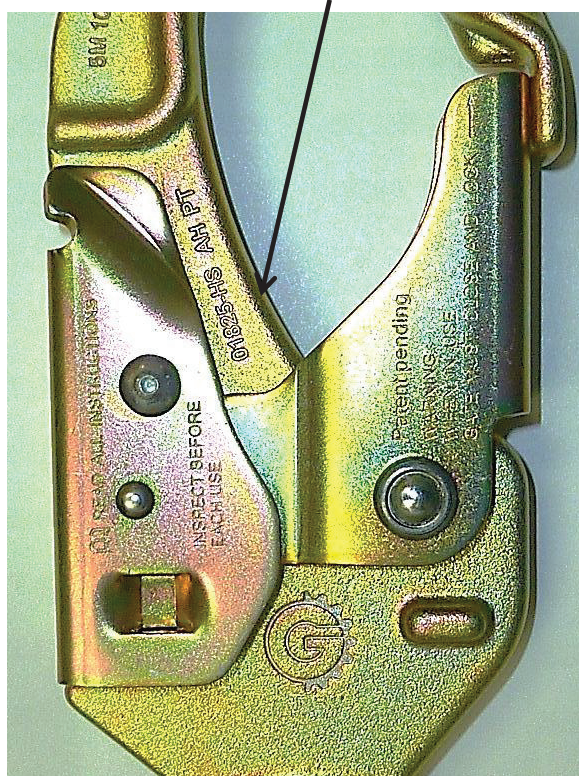
Marked with part # 01825-HS or 01826-HS on the hook body

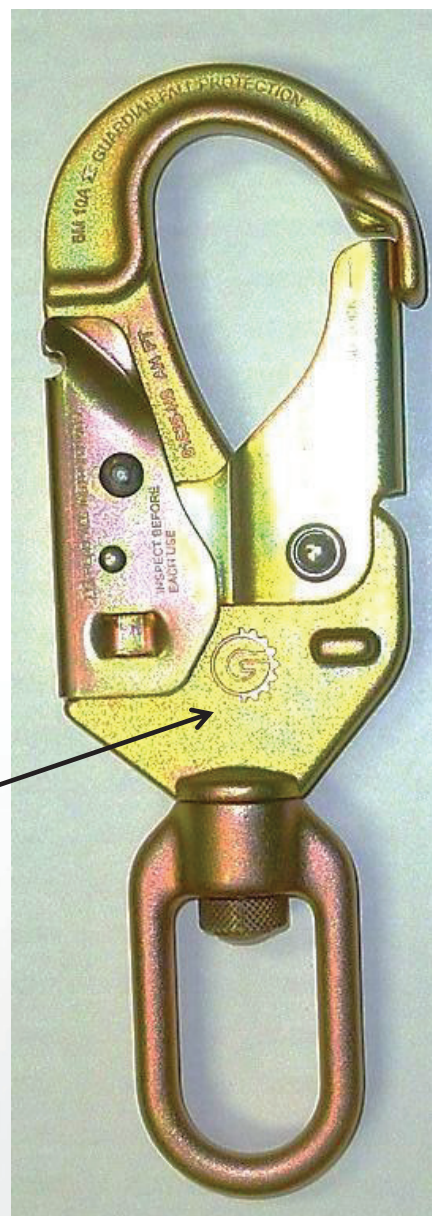
Full photo of the potentially defective swivel snaphook.

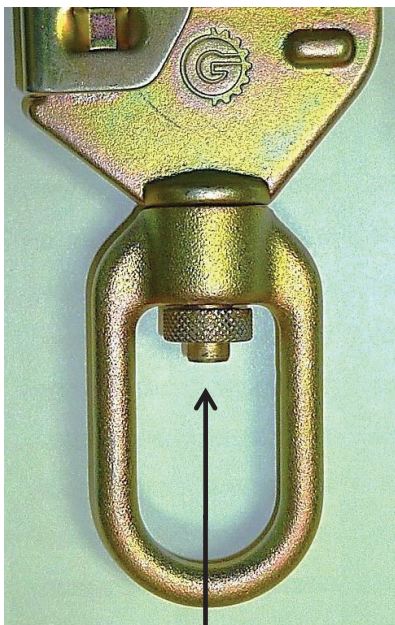
DEFECTIVE CONDITION

The potentially dangerous and faulty condition was caused when GFP's supplier of a particular swivel snaphook missed a swaging operation that encapsulates the swivel eye and prevents the threaded nut from backing off of the hook stem. This situation is restricted to a certain type of swivel snaphook supplied to GFP and is identified in this notice. Upon discovery, both GFP and the supplier have increased inspection processes to ensure this cannot occur in the future. Supplier and GFP inventories have been inspected for this condition upon discovery. **No defective units were found in inventory.** Any products you receive after June 26th have been 100% inspected specifically for this condition and any other defect.

BAD HOOK. STEM PROTRUDES STRAIGHT THROUGH THE NUT. STEM HAS NO MUSHROOM SHAPE FLARED OVER THE NUT. NUT CAN BACK OFF THREADED STEM.

Remove the product from service immediately.

Contact Customer Service at GFP (800-466-6385) to be assigned a unique RQC- return number. Guardian will provide shipping instructions for returning products and coordinating replacements for units that have the defective swivel snaphooks. Guardian will replace the product and cover the freight costs.

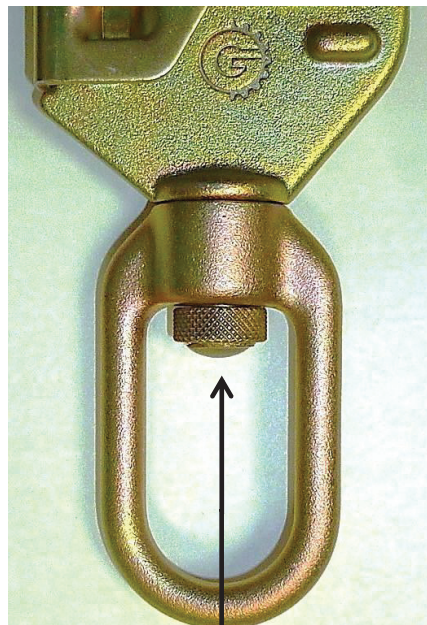
NORMAL CONDITION

NORMAL SWAGED HOOK. GOOD HOOK. STEM FLATTENED IN A MUSHROOM SHAPE. ANY SORT OF SWAGE MEANS HOOK IS GOOD. NUT CANNOT BACK OFF STEM.

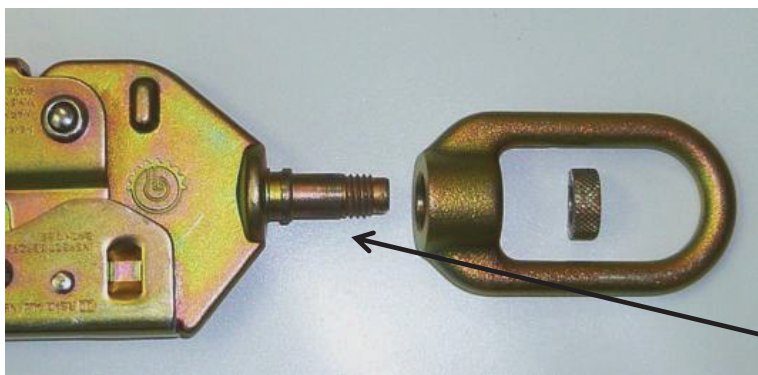
BAD HOOK. STEM OF HOOK BODY WAS NOT SWAGED OVER NUT. THREADED NUT IS CAPABLE OF SPINNING OFF THE STEM.
