# SAFETY ALERT

## Fire Extinguisher Incident

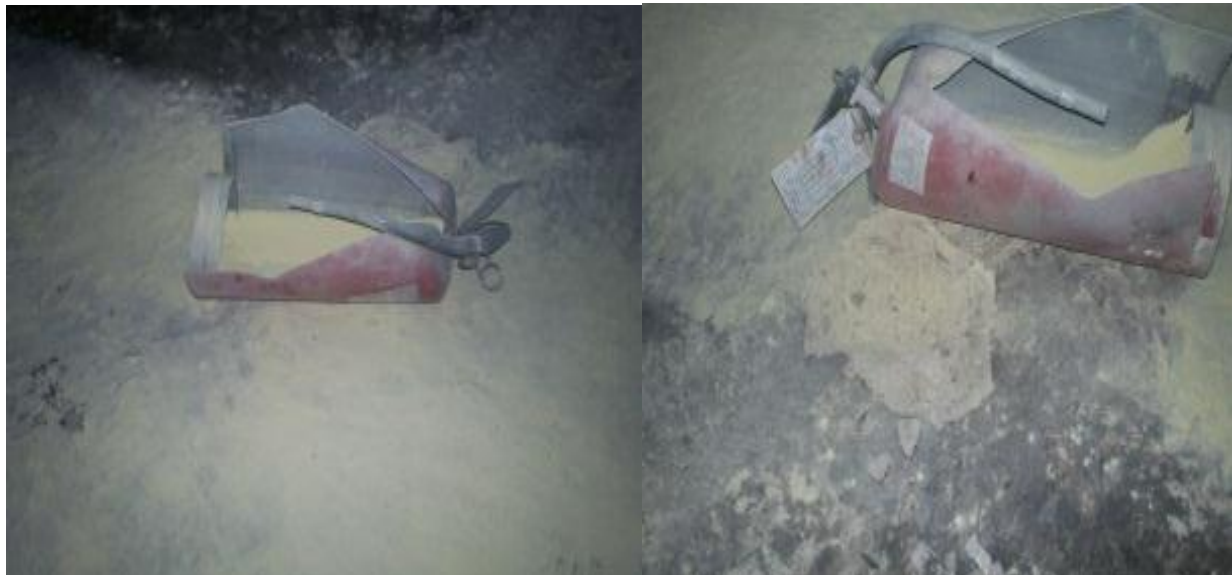
Sunday February 12, 2012 @ 7:30 am an Emeco field mechanic was completing his weekly service vehicle inspection. He grabbed the fire extinguisher mounted in his truck and noticed that the powder contents had settled at the bottom of the canister. He tapped the bottom of the fire extinguisher with a rubber mallet to help loosen the chemical contents.

The fire extinguisher erupted (exploded) causing the canister to shoot towards the ground and the chemical contents to release into the workers face. The force of the discharge removed his hard hat and covered him with the powder chemical. A co-worker assisted him to the nearest eyewash station and began flushing his eyes, then was taken to the Fort McMurray hospital for further eye examination.

Emeco has engaged "Fire Protection" (an industry expert) to assist in the investigation and they are inspecting the canister. Their initial inspections suggest that the fire extinguisher may have evidence of a defective weld on the bottom of canister.

1. Visual inspection should only consist of the following
  - a) verifying that the fire extinguisher gauge is still properly charged
  - b) verify external inspected within the last year
  - c) the pin and hose are present and in good condition
  - d) the fire extinguisher canister has no visible damage or rust
2. Fire Extinguisher experts recommend **no hitting or tapping the bottom of fire extinguishers with any blunt objects**, only use palm of hand.
3. Vertical or horizontal mount of fire extinguisher needs to be followed as per manufacturer's recommendations.
