## Mining the Diamond Alert

### Event

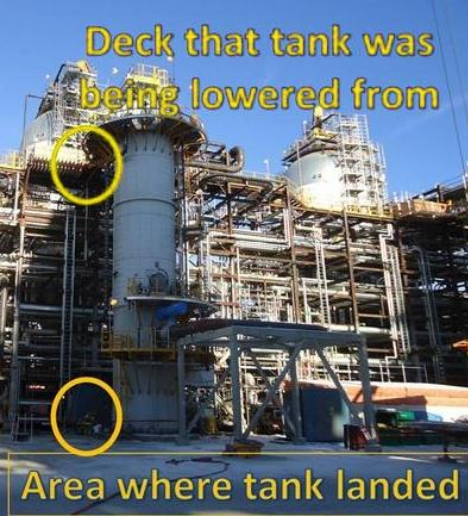
Deck that tank was being lowered from

Area where tank landed

A three person Hydro crew (pipefitters) were tasked to lower a 20-pound propane cylinder from a deck approximately 60 feet above grade using a rope and a propane cylinder sling. A quick release knot was used to secure the rope to the propane cylinder sling. While lowering the cylinder, it is believed that the frayed end of the knot caught in the grating and the weight of the load caused the knot to untie; as a result the propane cylinder dropped approximately 55 feet to the ground. The cylinder was damaged upon impact, but was not breached. The Emergency Response Team was notified and they assessed the cylinder for leakage (no leak detected). The propane tank was removed from the area and was taken to a safe location to be vented (emptied). No one was injured; however, a person was only 5 feet from where the cylinder impacted the ground.

1. Contractor to design purpose built ropes with pelican hooks for lifting/lowering smaller tools and equip tool cribs with dedicated standard lengths of rope for this work.
2. Contractor to develop a standard for knot usage and selection, specifying which knots are acceptable for each discipline and operation.

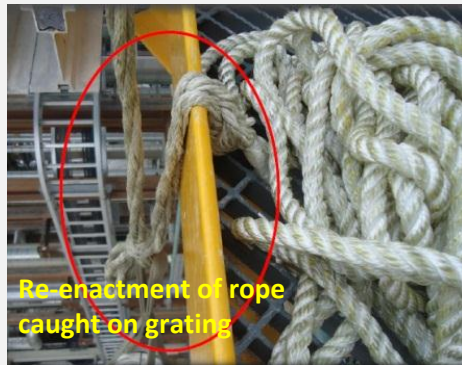
Re-enactment of rope caught on grating

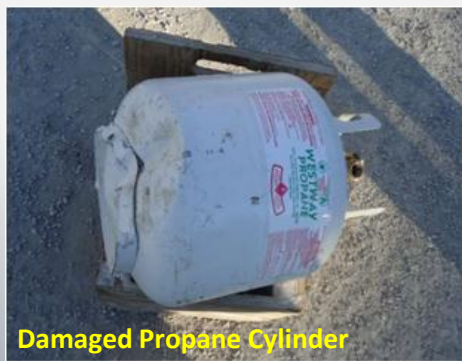
Damaged Propane Cylinder
