SAFETY ALERT

Ruptured Pressurized Fire Extinguisher

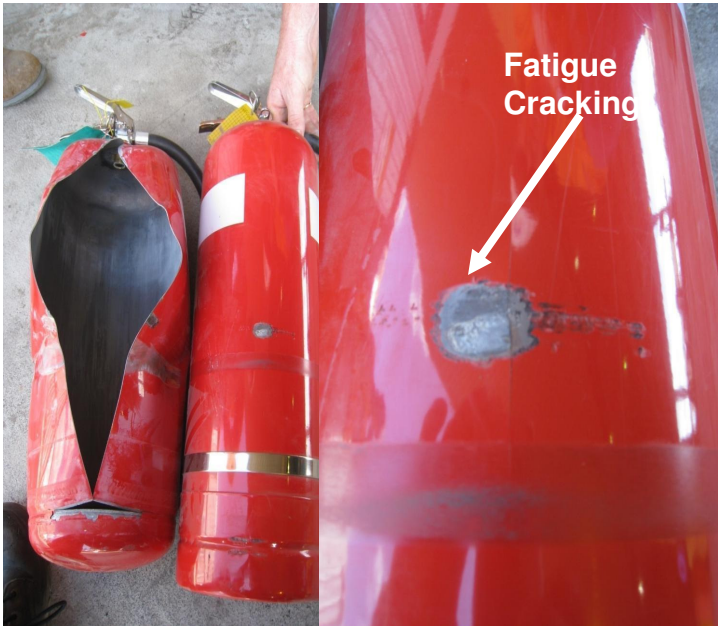
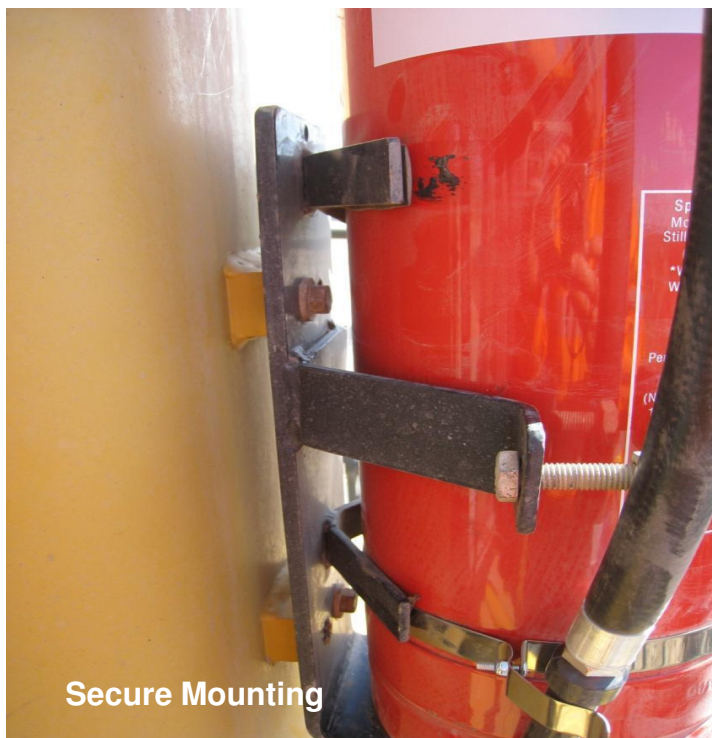
A pressurized fire extinguisher mounted to a Dozer ruptured and exploded due to loose mounting. The friction from the bracket strap rubbing against the fire extinguisher resulted in fatigue cracking of the fire extinguisher canister.

The fire extinguisher was not securely mounted on the vehicle to prevent rubbing between the bracket strap and fire extinguisher.

- Inspect the mounting on all fire extinguishers on moving equipment to ensure that they are secure and there is a tight fit between the fire extinguisher and the mounting bracket.
